**Lab & Field Test Results
and Product Application**
SDS BIONIC WORLDWIDE

SDS BIONIC METAL COAT

Standard Test Results

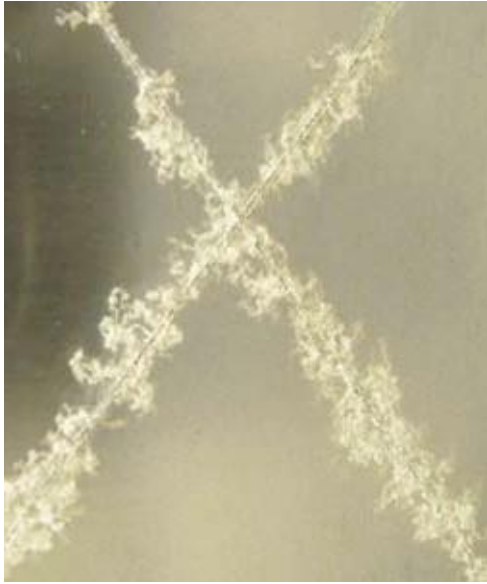
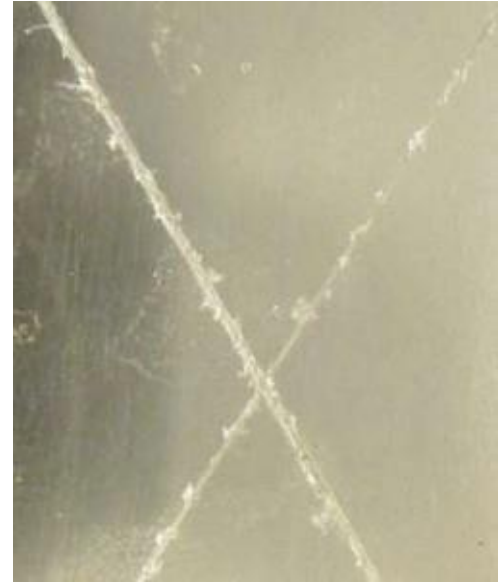
Both samples were scribed with an X and exposed to NSS for 23 hours and were placed in humidity cabinets set @40°C and 80% RH for 6 weeks

Test	Result
ASTM D-3359-09 Adhesion Standard Test	300 Hours 4B
ASTM D-3363 Film Hardness Taper	39.11 Average
ASTM D-2047 Static Coefficient *Always obtain independent retest of the static coefficient after applying any coating on walking surface to verify new application meets OSHA requirements.	Passes ADA Requirements*
ASTM D-2803-03 Procedure B (ISO 4623) Corrosion and Filiform.	No Filiform or Corrosion 1,000 Hours.
E96-10 Water Vapor Transmission	Average WVT 0.3473 gr/ft ² /hr, Average Perms 0.8376 gr/ft ² /hr
G155 Xenon Arc, Wavelength 340nm Irradiance 1.0 w/m ²	500 Hours, Slight Change
ISO 4623 International Standard Corrosion	No Corrosion
ISO 4628-10, International Standard, Degradation of Coating	No Degradation Coated Over Primer.

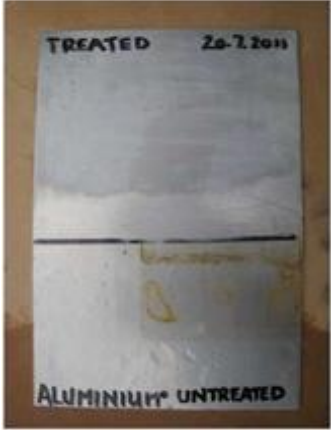
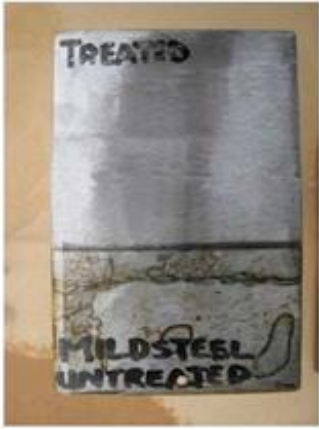
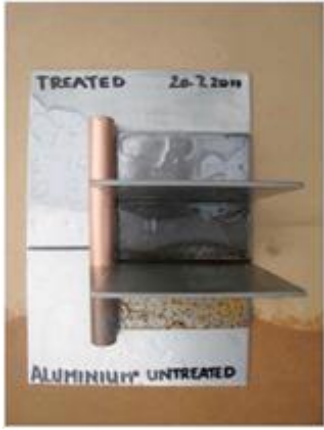
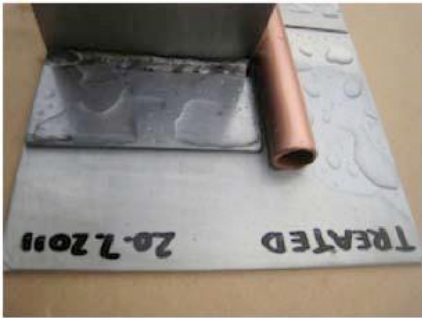
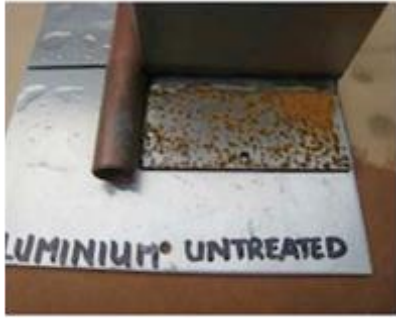
DAY 5 - July 25th, 2011

STANDARD ALUMINUM	MILD STEEL	MIXED ASSEMBLY

MIXED ASSEMBLY SDS TREATED	MIXED ASSEMBLY SDS UNTREATED

Test Details	Result
<p>July 25th – Day 5 The assembly has been placed in the environment for 24 hours. Temperature: 10 Degrees Celsius Rain</p>	<p>Aluminum, Metal and Assembly after 1 day of exposure to the environment continues to show rust and continued electrolysis on the untreated half.</p>

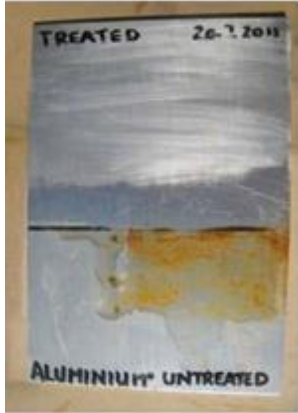
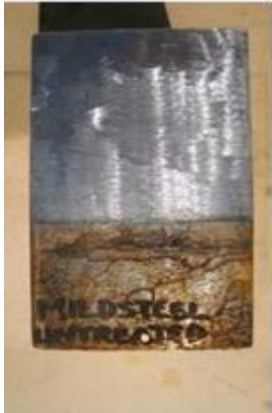
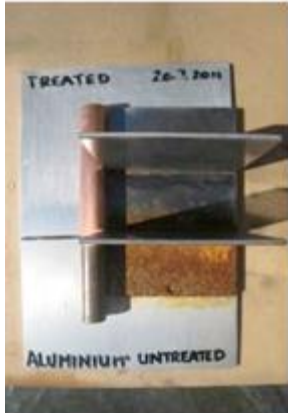
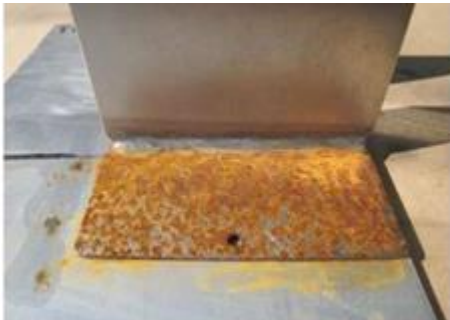
DAY 30 – August 20th, 2011

STANDARD ALUMINUM	MILD STEEL	MIXED ASSEMBLY

MIXED ASSEMBLY SDS TREATED	MIXED ASSEMBLY SDS UNTREATED

Test Details	Result
<p>August 20th – Day 30 The assembly has been placed in the environment for 24 hours. Temperature: 19.4 Degrees Celsius Sunny</p>	<p>Aluminum, Metal and Assembly after 30 days of exposure to the environment shows the rust truly setting in and where the copper tube is sitting, the aluminum is being eaten away in 3 areas due to electrolysis on the untreated half.</p>

August 20th – Day 30 The assembly has been placed in the environment for 24 hours. Temperature: 19.4 Degrees Celsius Sunny	Aluminum, Metal and Assembly after 30 days of exposure to the environment shows the rust truly setting in and where the copper tube is sitting, the aluminum is being eaten away in 3 areas due to electrolysis on the untreated half.

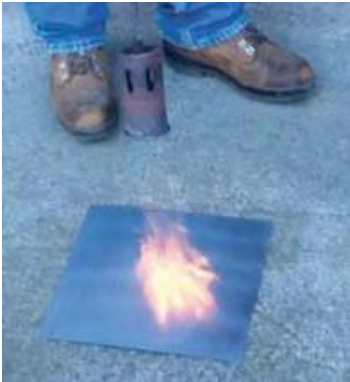
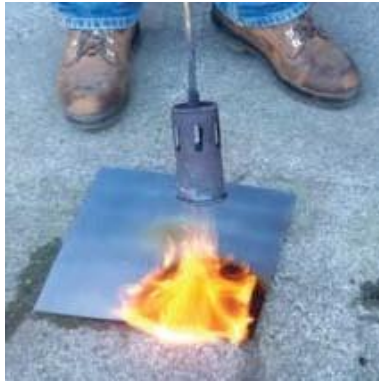
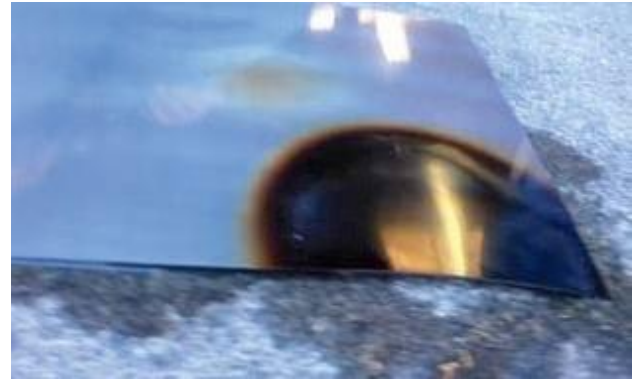
Unpainted Mild Steel

Test Details	Result
Unpainted mild steel coated with SDS-BIONIC Metal Coat was heated with an 1800 degree propane torch for 3 minutes.	While the metal darkened beneath, the Metal Coat coating did not ignite, blister or peel.

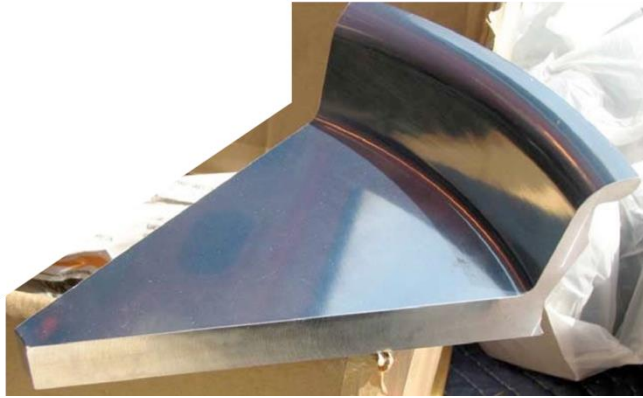
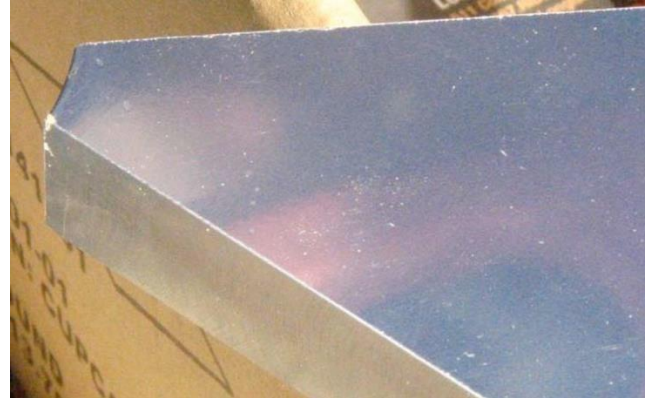
Large Truck Wheel Rim

Test Details	Result
<p>The following photos are of a large truck wheel rim coated with SDS-BIONIC Metal Coat for Alcoa Aluminum. The coating was being tested for protecting their new line of truck rims being manufactured in China.</p>	<p>After successfully passing all their tests the test rim was then cut into pie shape samples for others to review the results. The shop doing the cutting was surprised that the coating did not chip, peel or flake after being cut with both band saw and C&C machine. Unlike other coatings both types of cutting had no effect on the SDS-BIONIC Metal Coat edges.</p>

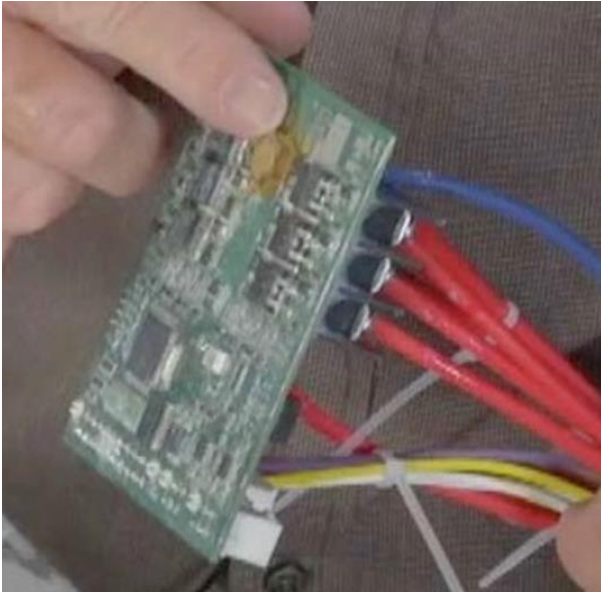
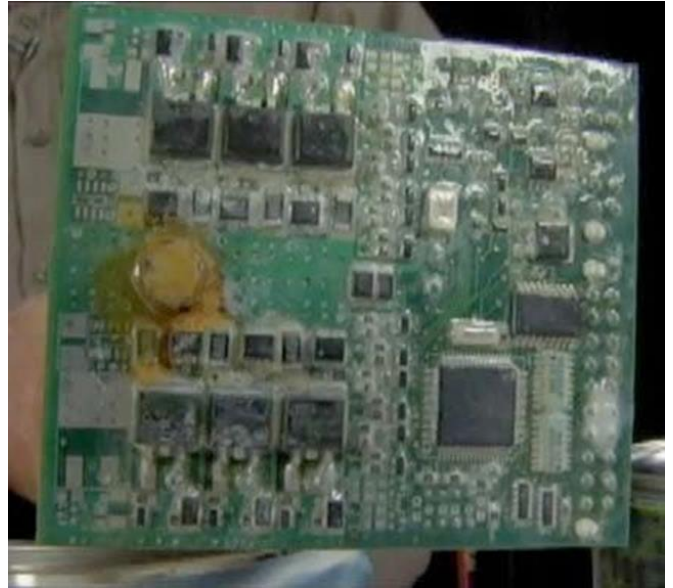
Circuit Board

Test Details	Result
A 30 amp, 220 volt circuit board, coated with SDS-BIONIC Circuit Coat was submerged while running in salt water.	The circuit remained running and lasted for 3 days, until a breach occurred, ONLY, due to the ground bolt which had not been coated.

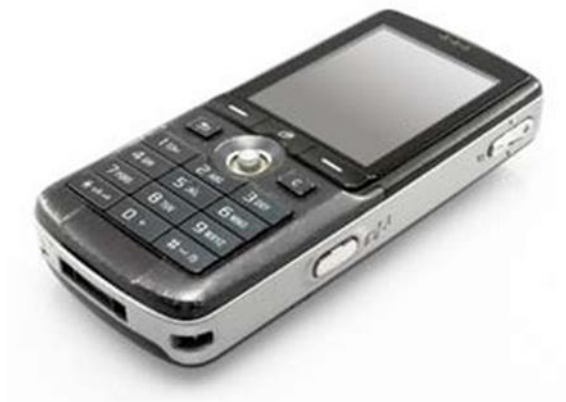
Circuit Board

Test Details	Result
Cell phone circuitry was coated with SDS-BIONIC Circuit Coat	After time for the coating to cure the phone was reassembled and submerged in water. After removal from the water the phone worked normally.

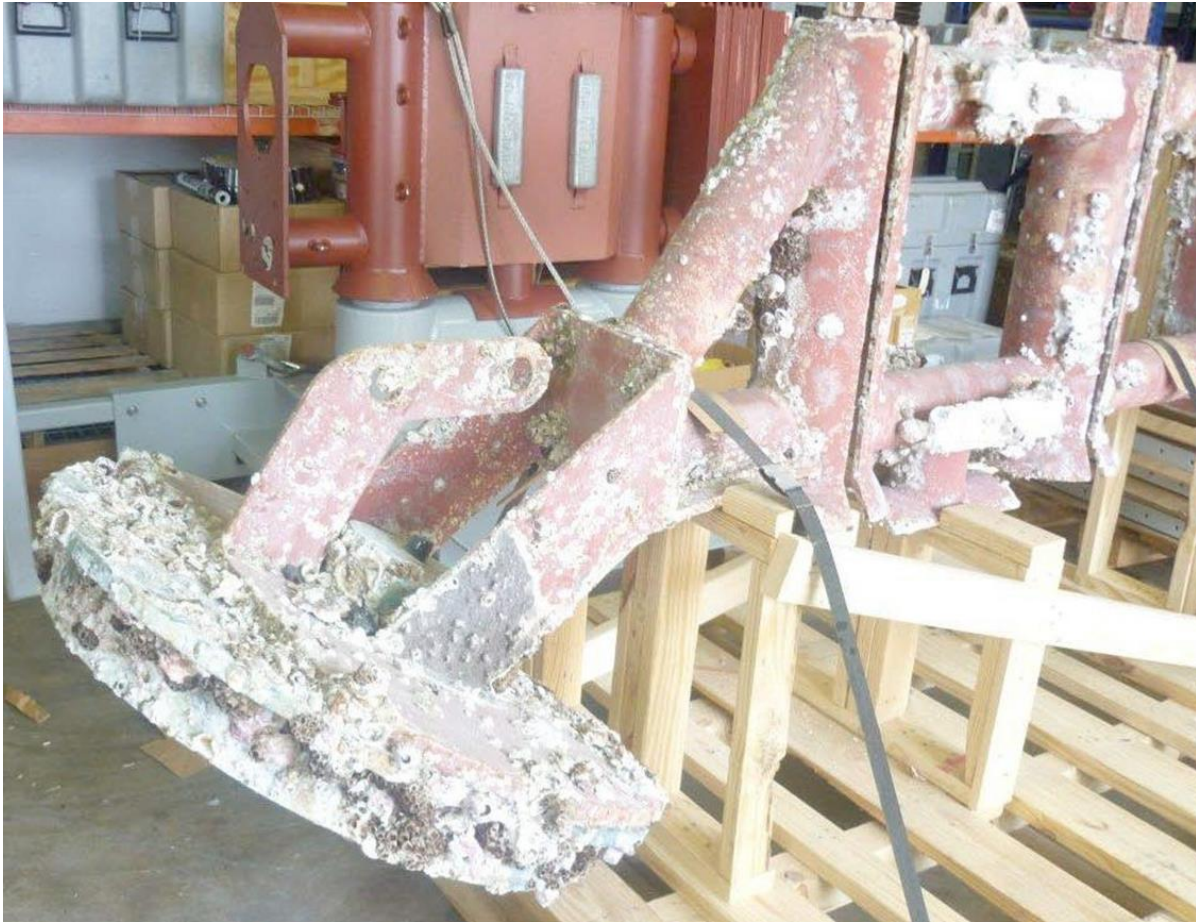
Test Details	Result
<p>British Marine Technology (BMT), a leading international, multi-disciplinary engineering, science and technology consultancy, is handling Doppler technology for Shell Oil. They were having to pull up and clean Shell Oil's Deepwater Doppler equipment at great expense every six months or less because of marine life over growth (as shown in the picture above) preventing clear imaging.</p> <p>The Doppler equipment was coated with SDS-BIONIC Marine & Hull Coat and placed at over 900 feet under water in the Gulf of Mexico in 2010.</p>	<p>After two years it still makes clear images indicating lack of marine growth on the sounding drum. As a result of this test BMT has approved SDS-BIONIC Marine & Hull Coat for all their Dopplers.</p>

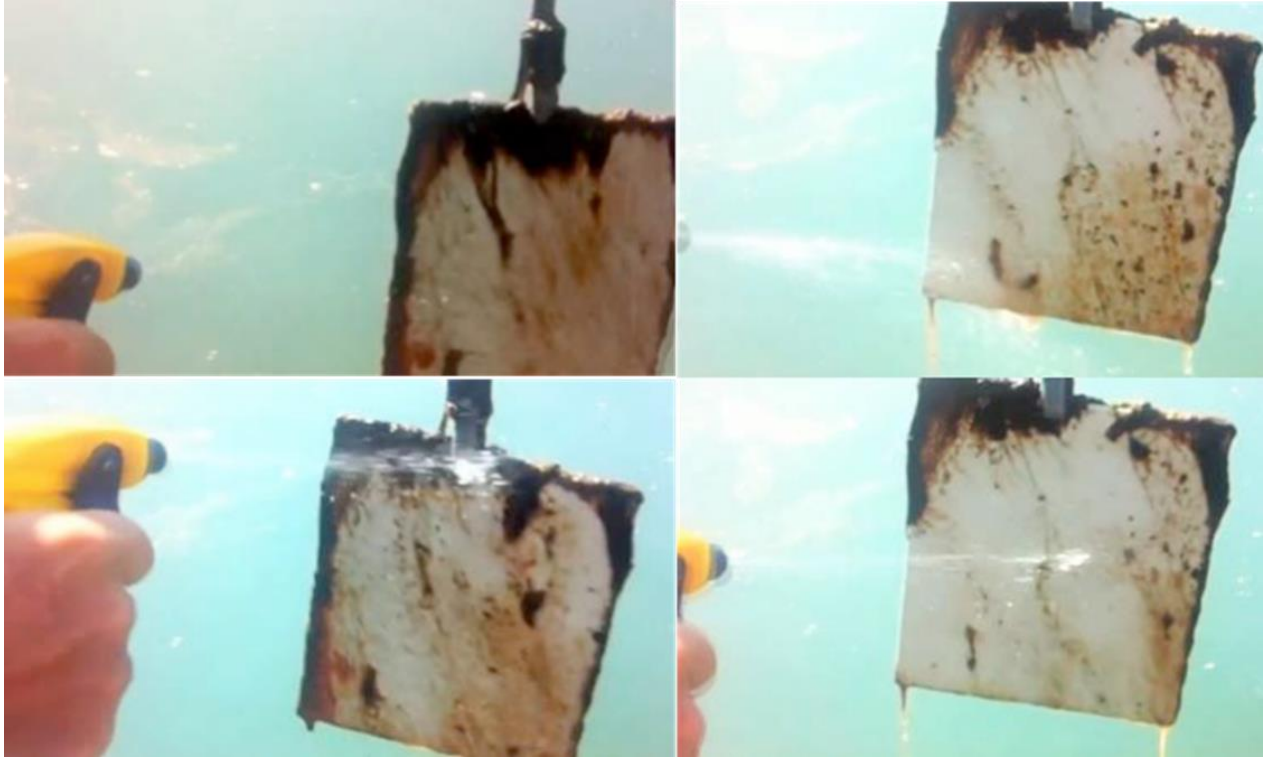
Steel Plate

Test Details	Result
A SDS-BIONIC Marine & Hull Coat protected steel plate after being submerged for two months	After 2 months the plate can be cleaned with just water from a spray bottle showing that no marine life had attached to the coated surface.

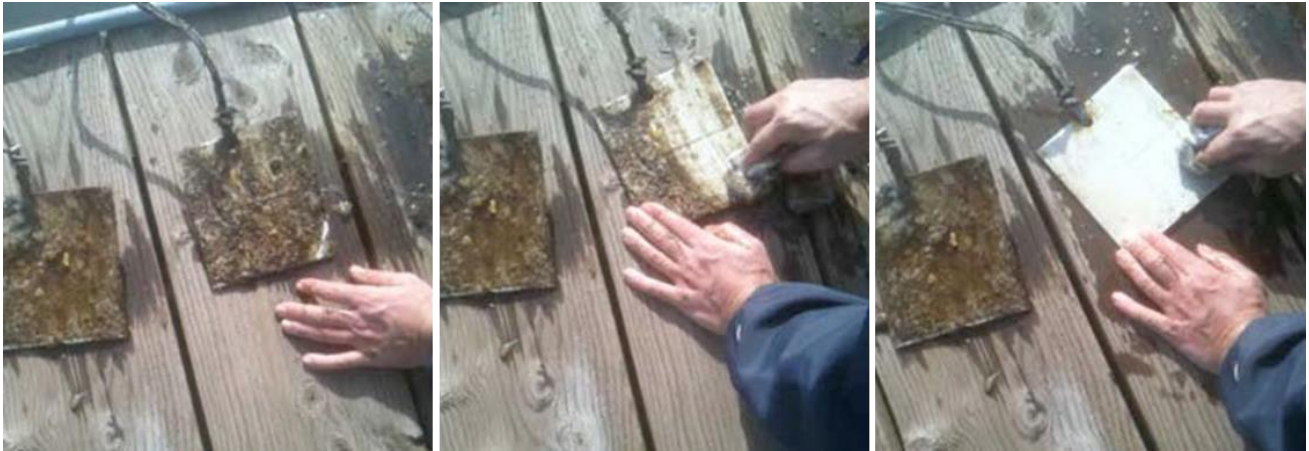
Steel Plate

Test Details	Result
A SDS-BIONIC Marine & Hull Coat protected steel plate after being submerged for eight (8) months	After 8 months the plate can be cleaned with just water from a spray bottle showing that no marine life had attached to the coated surface.

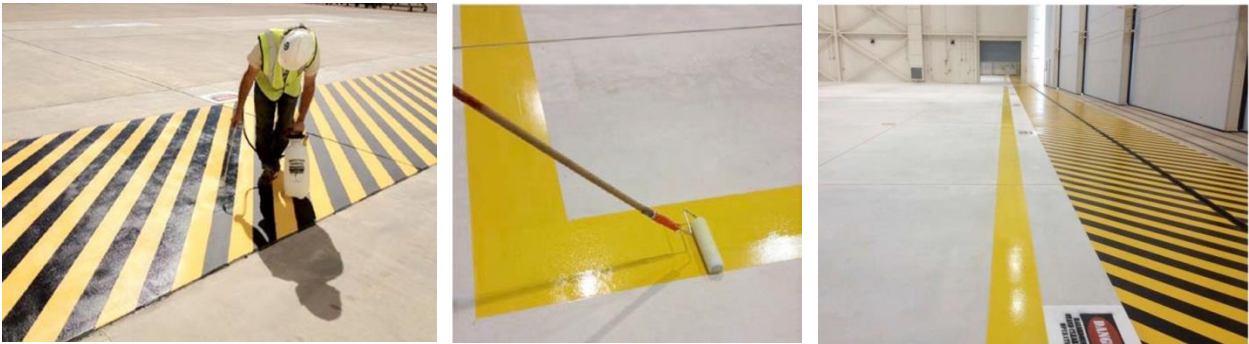
AIRPORT HANGER

Application Details	Result
<p>Completed April 21st 2012, SDS BIONIC Concrete Coat was Applied on painted surfaces at Dyess Air Force Base. The majority of the project was top coating yellow and black diagonal caution striping inside and outside of both hangar doors. There is over 6,000 sq. ft. of striping installed. This hangar had two identical halves used to maintain three Air Force planes: C130H, C130J, and B1b. All painted surfaces were coated with Concrete Coat.</p> <p>Caution stripes were installed outside with an airless striping sprayer and then top coated with SDS BIONIC Concrete Coat the next day using a pump-up sprayer.</p>	<p>The painted surfaces now treated with SDS BIONIC Concrete Coat will resist oils and staining. The floor will be easy to clean, maintain, and they will last many years longer than ordinary paints as well as resisting stains better than epoxy or polyurethane.</p> <p>The coated surfaces had paint spilled on them after installation and we could wipe it off with Xylene or Acetone with complete removal and no loss in gloss.</p>

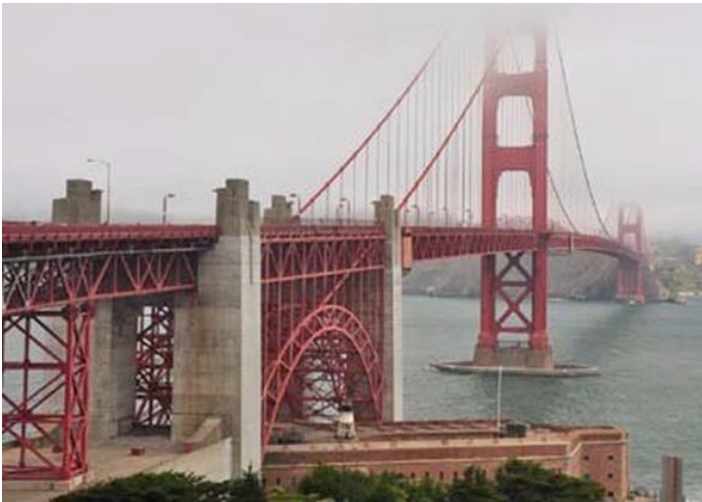
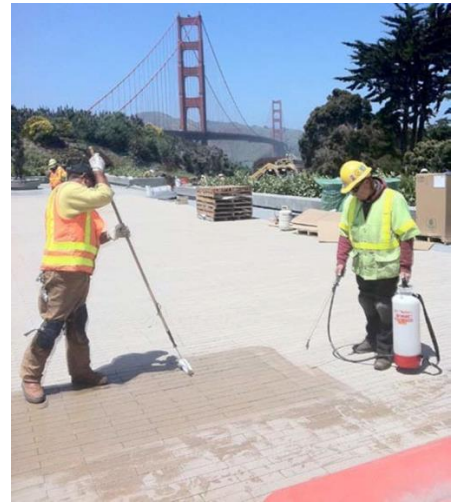
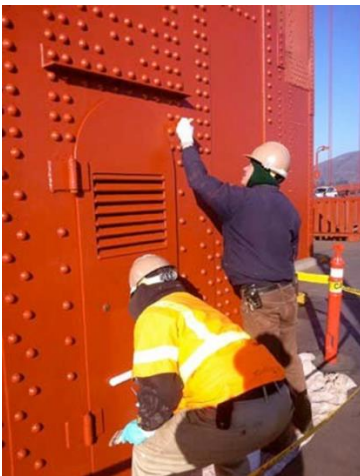
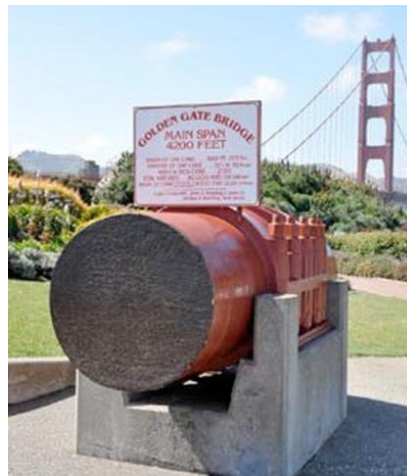
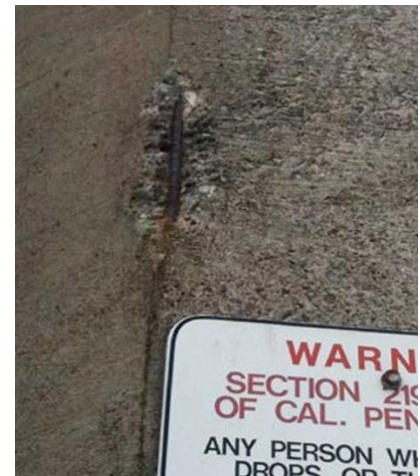
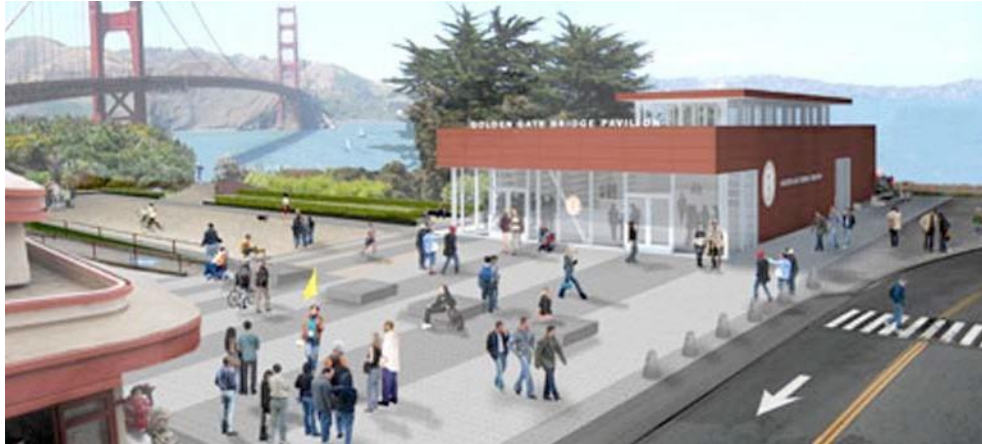
BRIDGE & COMMON AREA

Application Details	Result
<p>The Golden Gate Bridge concrete cable and tower footings show signs of deterioration, becoming more porous and allowing the metal rebar to rust and corrode. SDS BIONIC Multi-Purpose Sealer will be used to protect these surfaces. They are also planning to use it to protect the historic civil war Fort Point under the bridge.</p> <p>Caution stripes were installed outside with an airless striping sprayer and then top coated with SDS BIONIC Concrete Coat the next day using a pump-up sprayer.</p>	<p>May 28th, 2012 was the 75th Anniversary of the Golden Gate Bridge. The Golden Gate Bridge District actively prepared for this event with the construction of a new visitor center and a renovation of existing buildings and walkways. SDS BIONIC Multi Surface Sealer was used on sidewalks and benches. SDS-BIONIC Metal Coat was applied to protect the interactive bridge model displays as well as the 27 ton display of a cross section of the cable used on the bridge pictured to the right. SDS BIONIC Concrete Coat</p>

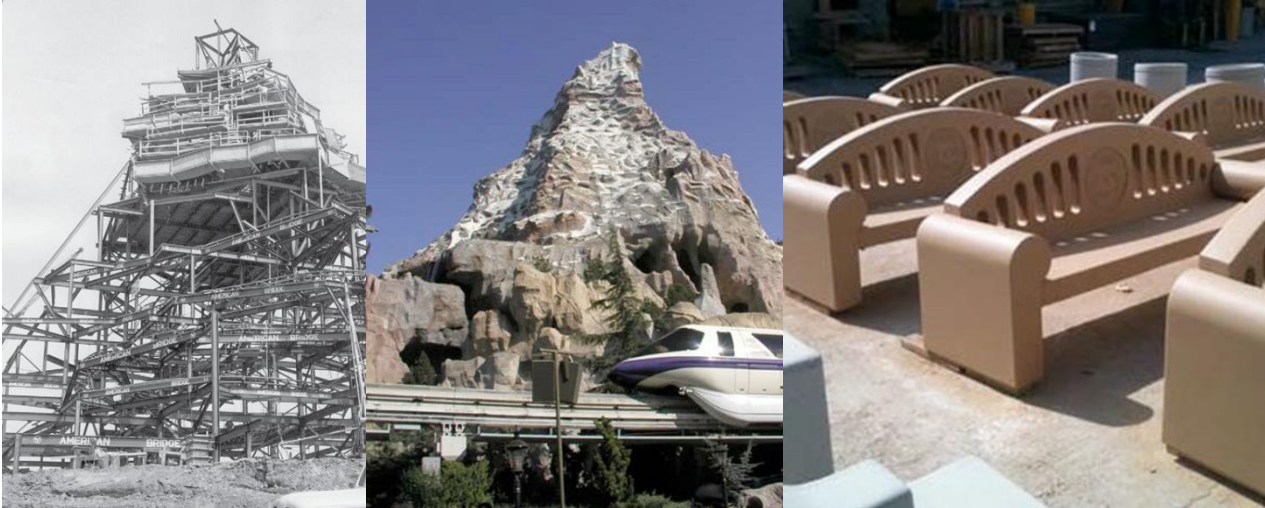
Application Details	Result
<p>The Matterhorn ride at Disneyland has a steel structure that gets epoxy coated two times a year to prevent corrosion. SDS BIONIC Metal Coat was applied in May of 2011 on a portion of the structure as a test. The coated steel has now passed all their testing, showing no signs of rust or corrosion in 11 months.</p>	<p>They are proceeding with application on the entire structure. The success of SDS BIONIC Metal Coat on the Matterhorn has led to planned use in many other areas of the park including the monorail.</p> <p>SDS BIONIC Metal Coat will protect it from corrosion, keep it clean and help keep the paint from oxidizing. This success is leading to use of SDS BIONIC products at Disneyland Resorts around the world.</p>
